Technical Note N- 1081

DEEP-OCEAN BIODETERIORATION OF MATERIALS -
SIX MONTHS AT 6,000 FEET

APRIL 1970

NAVAL CIVIL ENGINEERING LABORATORY
Port Hueneme, California 93041

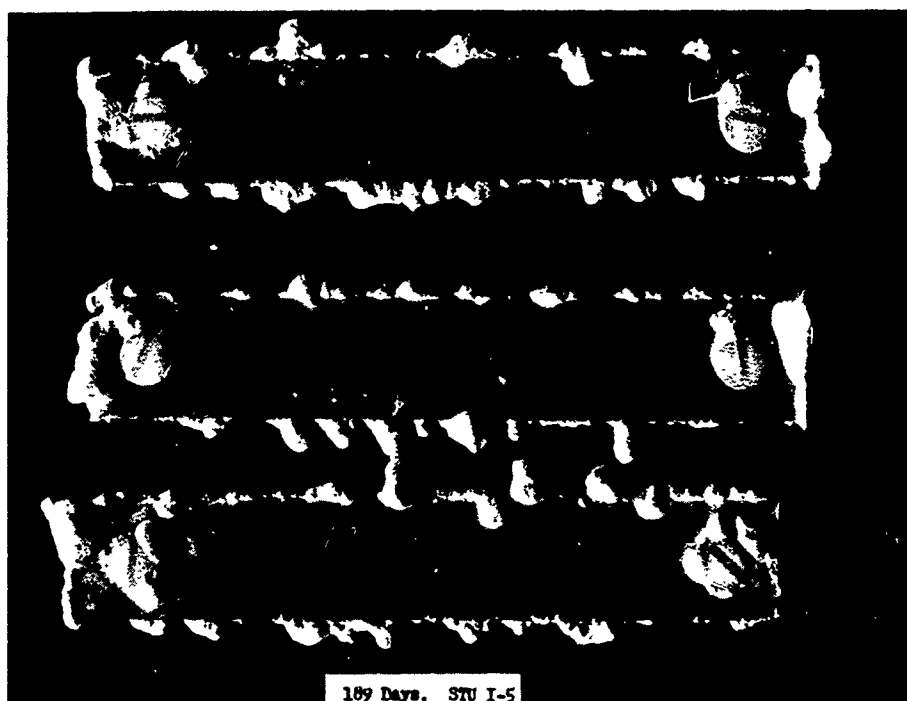
Figure 20. "Exposed" aluminum alloy test panels with corrosion products formed along the ends and edges.
